## SATIN Case Study - Upland path repairs protecting Steall Gorge

John Muir Trust for wild land and wild places

Steall Gorge, Glen Nevis

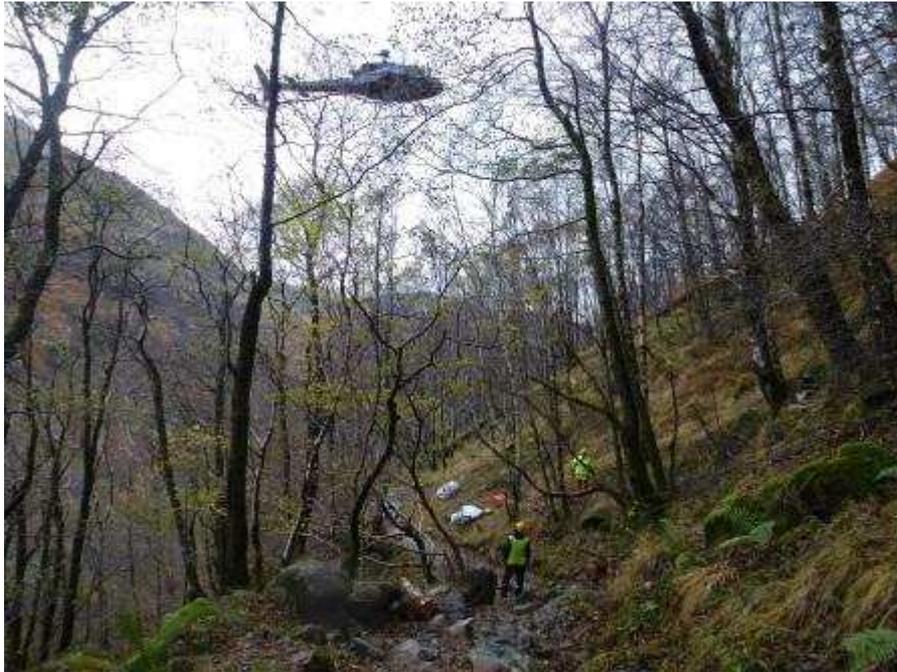
Helicopter landing bags of stone on a long line

**Helicopter airlift** - An airlift was complicated by several factors: the steep ground onto which the bags of stone were being placed; by the surrounding trees; need to operate a long line with the helicopter; by the popularity and number of walkers using the path; and with the flight path of the helicopter passing over the Glen Nevis road. This necessitated a road closure order for which permission obtained from Highland Council and a lot of publicity work to alert the public of the forthcoming works asking them not to use the path if possible during the days of the airlift. The airlift was delayed by poor weather but when it finally got under way took two days and required further tree felling on the day as the pilot was working in very close proximity to the tops of trees. Several staff were required during the airlift: to manage the landing sites for the bagged stone; to hook the bags onto the lifting cable; to undertake further tree felling; and to marshal the start and finish of the path in case walkers came along.

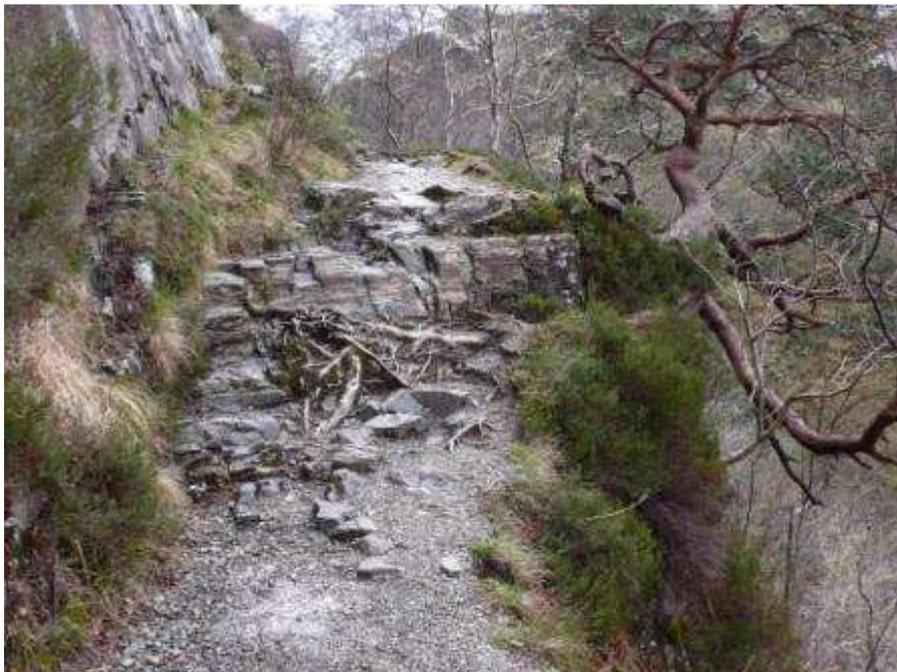
Before - awkward and slippery tree roots

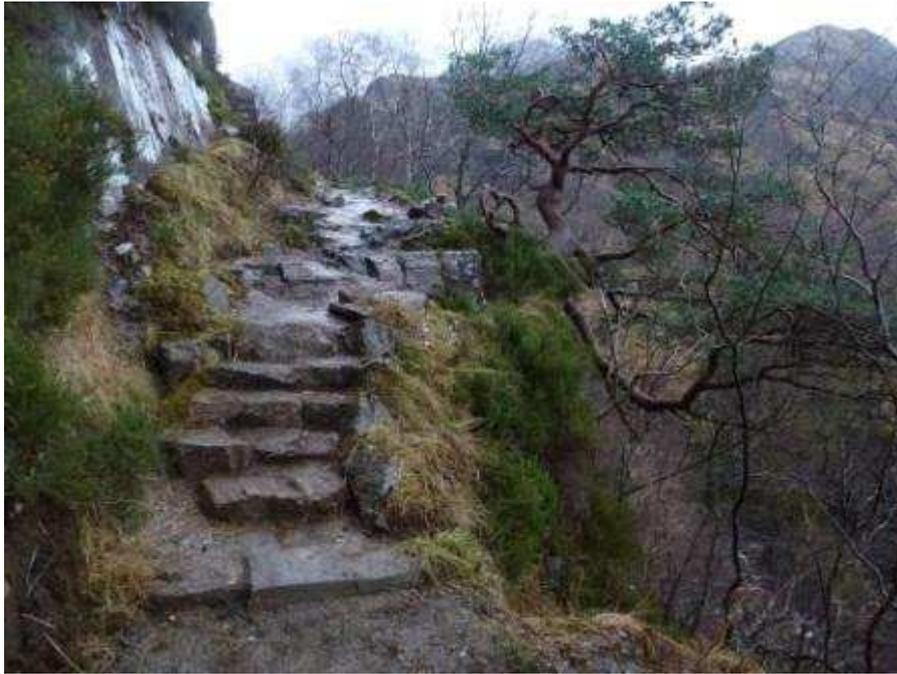
After - stone steps built over tree roots to protect them

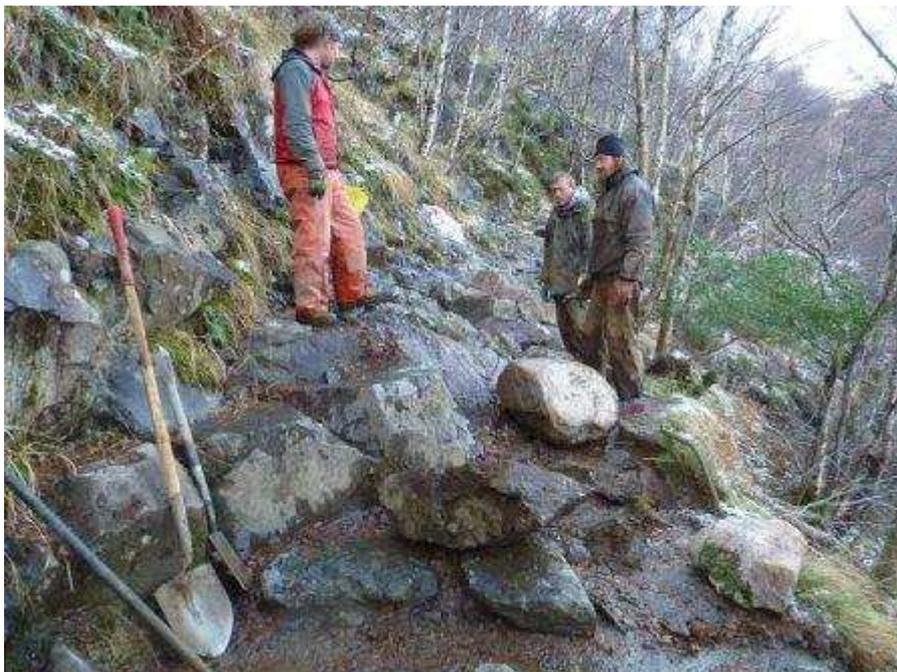
Before - awkward bedrock section with braiding on the right hand side

Where revetment was required on awkward bedrock sections Arran Footpaths developed revetment 'veins' which filled in hollows in the bedrock but left protrusions of the bedrock showing in between. Once landscaped this proved to look very natural and meant that the awkward surface of the bedrock (which was causing a bottleneck in the path and leading to trampling of vegetation at the side) could be surfaced with aggregate (gravel and fines) which were retained by the revetment.

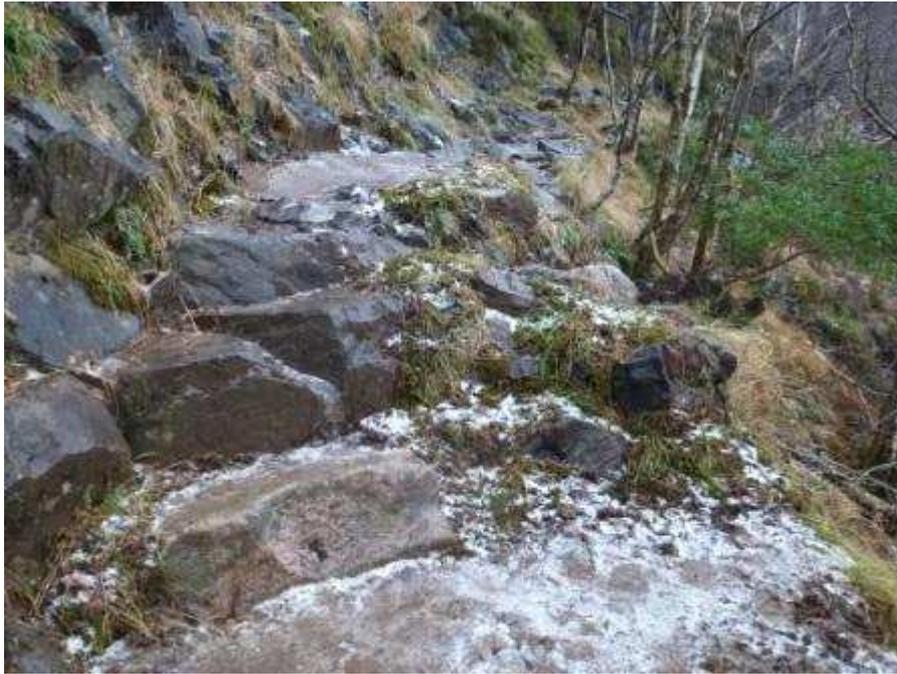
After - revetment veins landscaped

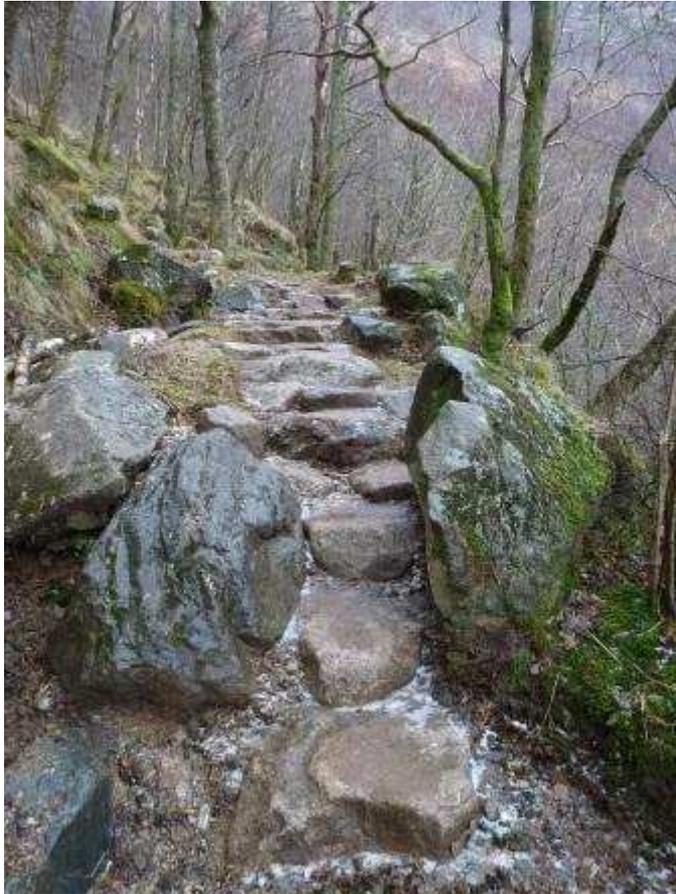
Boulders incorporated into path as features
