## SATIN Case Study - Use of Locally Won 'As Dug' Materials for Path Construction

Paths for All

Oatridge College, West Lothian

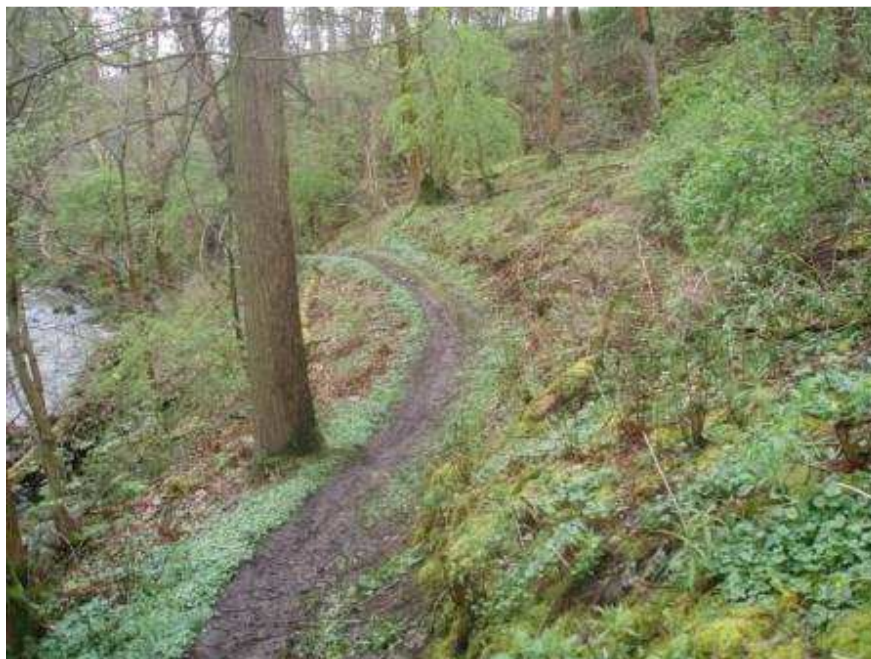
The existing route formed part of a short loop through woodland at Oatridge College.

Mainly used by local residents, staff, and students at the college, it cuts across the side of a steep slope which was muddy and slippery underfoot.

The aim of this demonstration path was to re-align the route to make it more accessible, improve the surface by constructing a new bench cut path and surfacing it using locally won 'as dug' material from borrow pits.

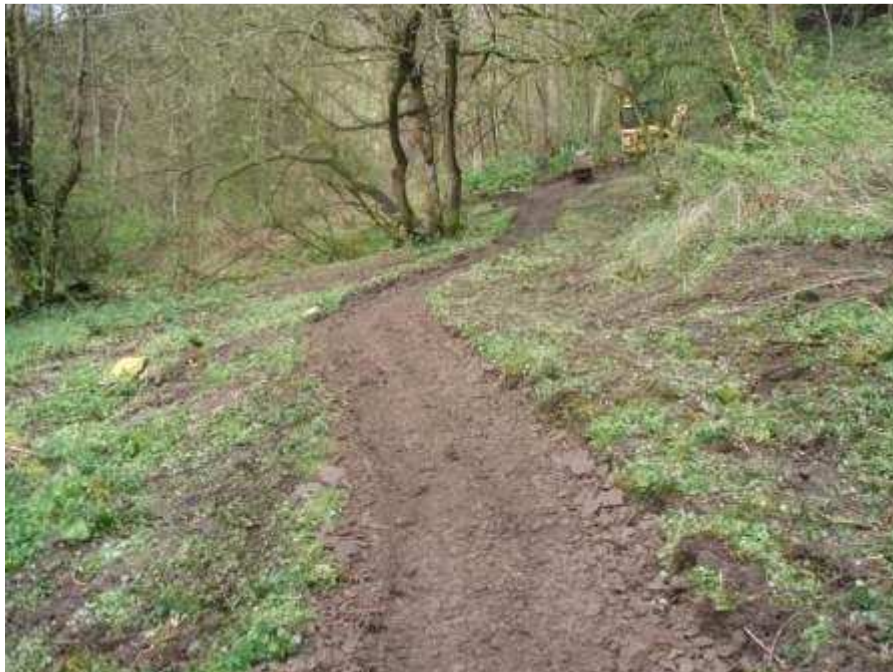
The 'as dug' path was constructed in 2008. It consisted of a 1.0m wide bench cut path through the woodland, with a total length of 320m. The initial work was to locate 'borrow pits' beside the path and to check if the material from those pits was suitable to use as path surfacing. The contractor advised that the shale material was unsuitable as it would retain water when wet. However, it was decided to continue using the material as it was a demonstration project aiming to illustrate the suitability of materials for path construction.

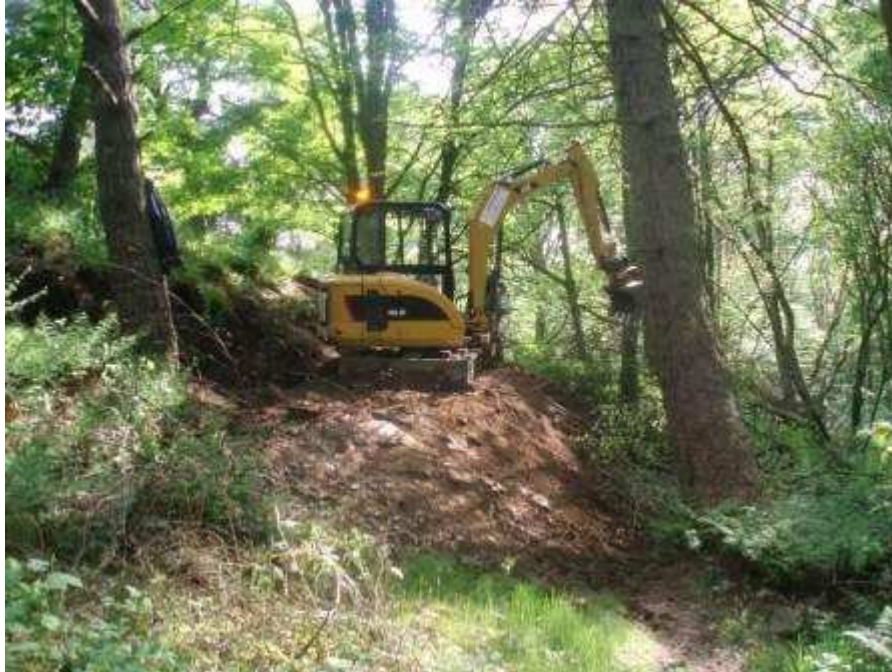
A bench was cut through the woodland using a 3 ton tracked excavator. The ground was steep and it was therefore difficult to undertake this 'cut and fill' technique. A ditch was constructed for approximately 30 metres alongside the eastern section of the path to catch surface water seepage from the slope, but the remaining length of path has no ditch. The path was constructed with a cross fall and as it was only 1 metre wide, was considered to be narrow enough to shed the water off the surface quickly.

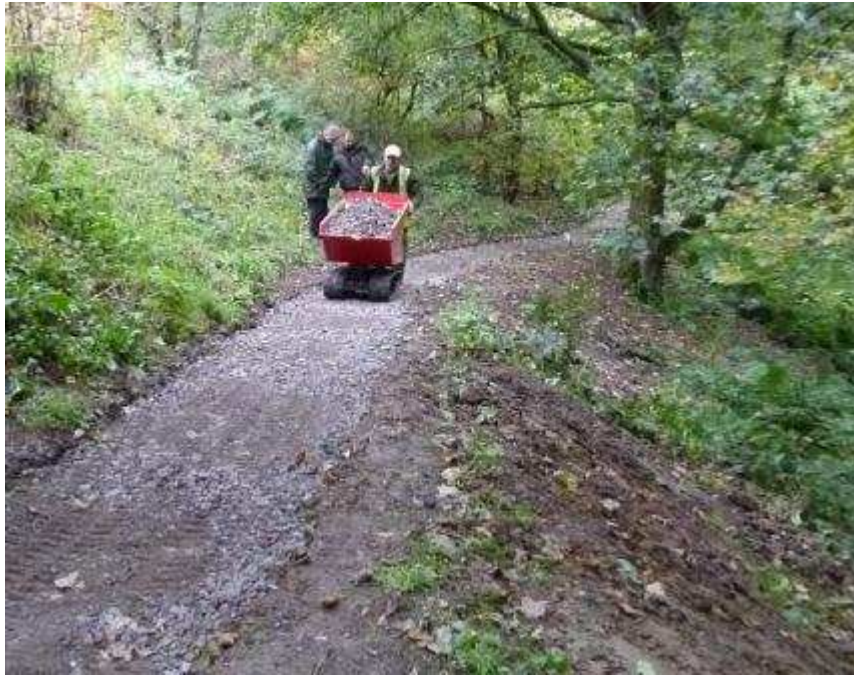
Recycled Type 1 granular sub base was laid on geotextile from the eastern bridge to the western end in order to allow a tracked power barrow to travel along the tray without causing damage to the trays base.

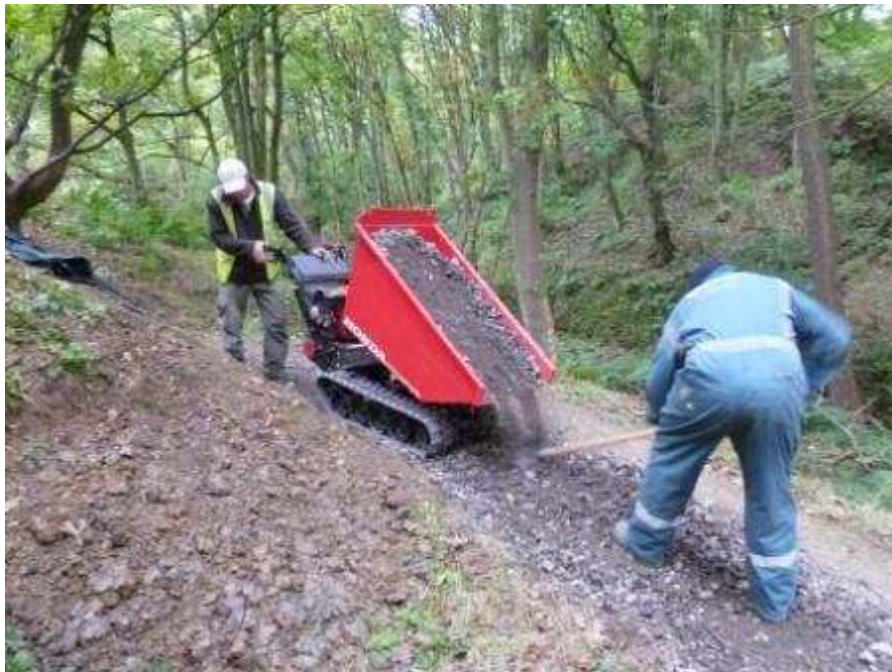
Further recycled Type 1 granular sub base was laid to form 100mm thick sub base layer with a cross fall, level with the adjacent ground. The sub base layer was compacted with a wacker plate.

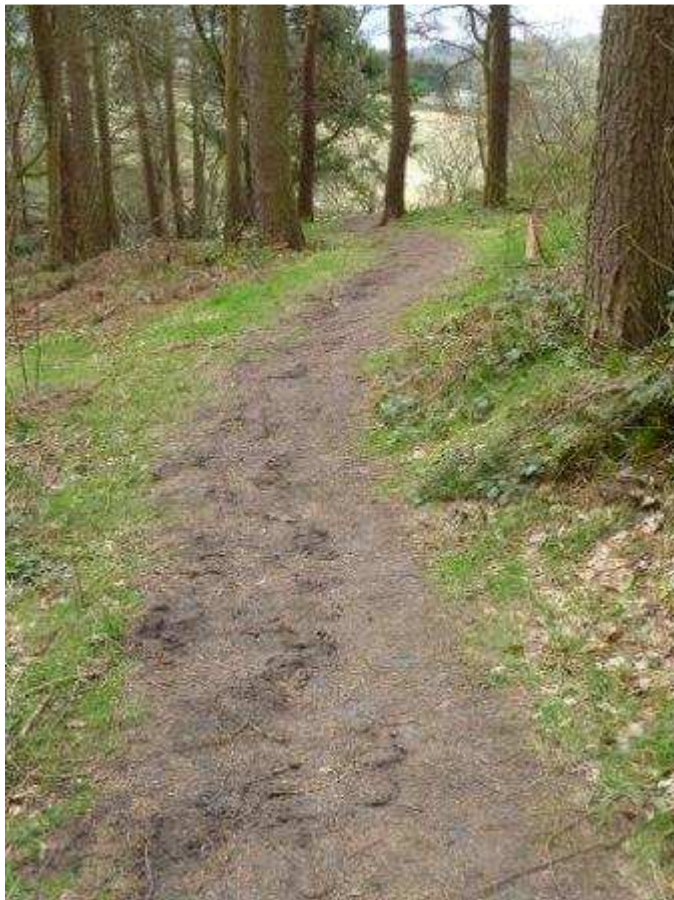
The resulting path was satisfactory in dry conditions, but not when it was wet as it became muddy, slippery and therefore hazardous. A lack of granular material in the shale material meant that it did not bind together well, and was not robust enough after rain.

The condition of the original 'as dug' path after drying out.

As a result of poor condition of the original 'as dug' path (see outcomes below), it was therefore decided to import recycled and quarried materials to upgrade the path and to make it fit for purpose. This path maintenance work was carried out in 2010.

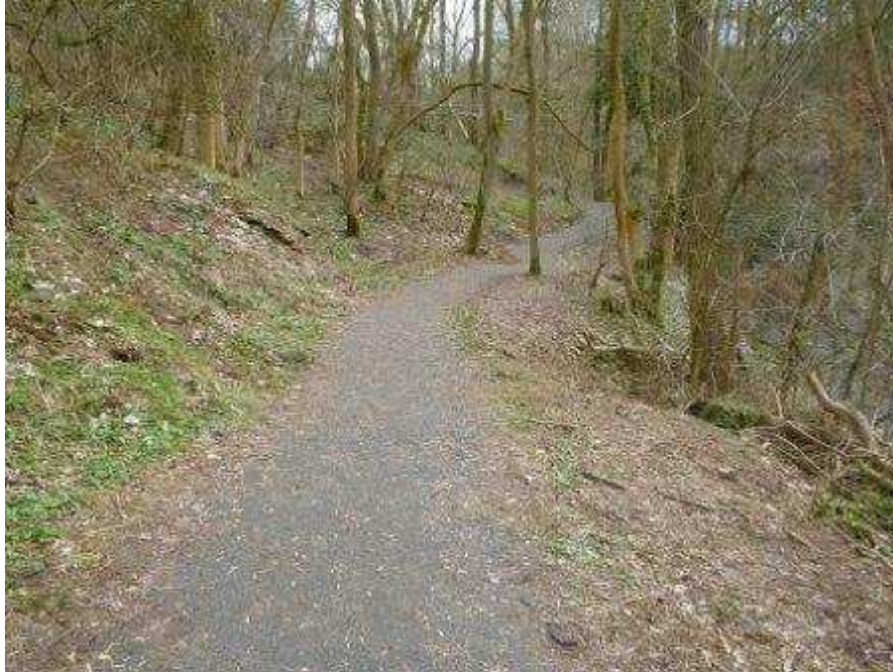
The resulting path is now dry underfoot and forms a very pleasant walk and ride through the woodland.

The condition of the new 'Type 1 and dust' path on top of the original benched route.
