UPAG Site Visit – 19th September 2016

Hosted by: The Nevis Partnership

Venue: Ben Nevis (Bottom half of the path)

Site Visit – Ben Nevis Mountain Path

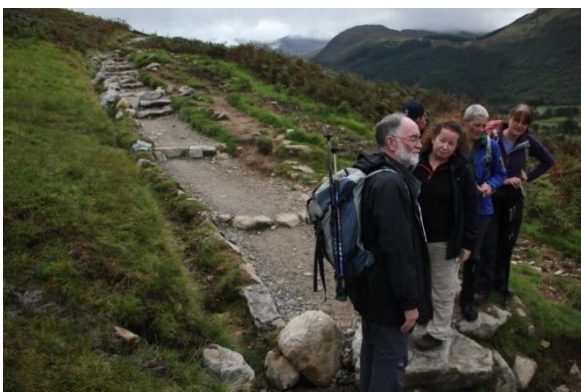
NLP are currently working in partnership with the National Trust for Scotland and are piloting Thistle Camps working on non-NTS properties. At the date of the UPAG visit two camps had visited previously and the third one was currently working on the lower slopes. We stopped to look at the work of the first camp which had taken place during a very hot week in May 2016. It involved a 100m section with predominantly aggregate path and a small amount of pitching toward to top end. The camp had also created a turf-lined ditch to the top side of the path.

There was lively discussion about this section of path. Although the work carried out by the Thistle Camp was agreed to be to a high standard, on account of their excellent supervision, Bob Aitken stated that the works had a deleterious effect. He considered the path to be too narrow and that without containment walkers would avoid the pitching to the top end of the section and walk on the vegetation to the side. The evidence on the day did appear to support this however, this was not actually the case. The landscaping to this section had been done in July as it was too hot and dry in May and was flourishing, however the Ben Race had taken place two week prior to the UPAG visit and it was the volume

of spectators which had caused the damage to the vegetation. This is something which perhaps needs some thought on how to prevent this kind of damage happening again as once damaged it could encourage walkers off the path.

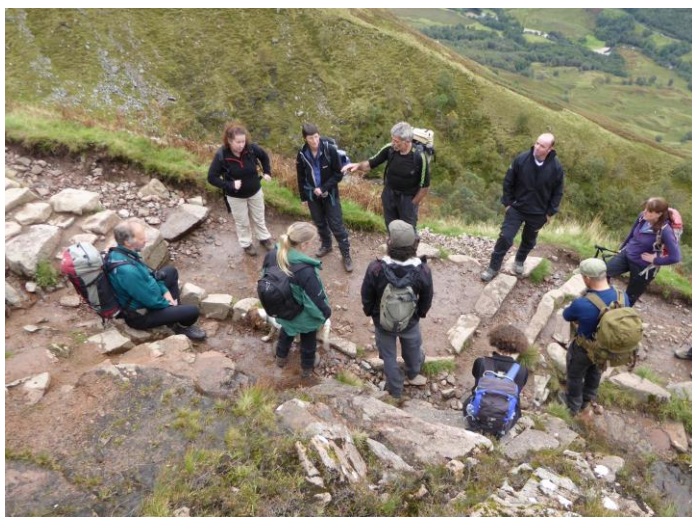
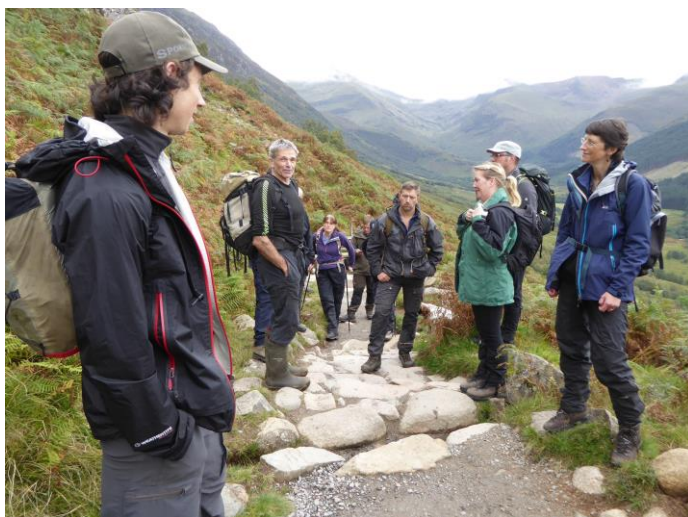
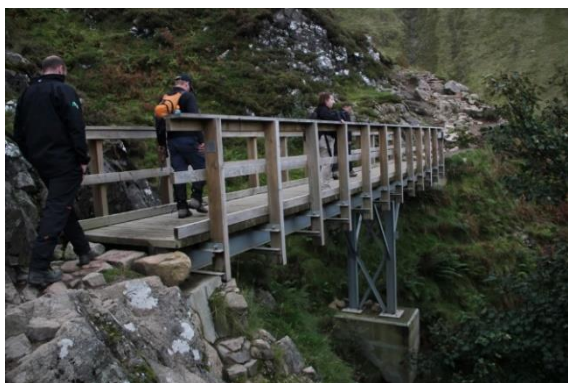
- The work on these contracts was predominantly heavy pitching with short aggregate sections. There were problems accommodating the path on bedrock, as it tended to creep and fall down the hillside. The contractor said he would have made the landscaping harder because if there was anywhere people could tread, they did, including on all the turf landscaping and in the ditches

- Some sections of pony pitching were not replaced as they were in good condition and stable. Available funding was tackling the worst sections where the path had completely collapsed.

- Several short-cuts across the zig-zags were noted. It is likely that the introduction of native tree planting in fenced enclosures will prevent this.

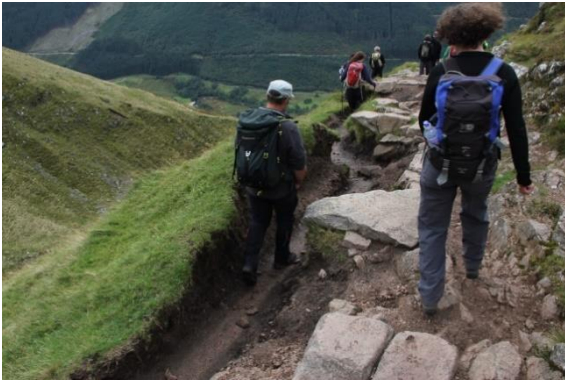
The groups looked at two path elements installed by the landowner. The culvert had a wet stone face and was out of keeping with everything else. As there had been no pathwork carried out on the path at the time of installation of the culvert there had been no protection on the upper side and the path surface had washed out almost immediately. The bridge, also installed by the landowner, was felt to be very robust however it was noted that the footing for the upper end of the bridge was

being undercut by the action of the burn. Both require remedial works.
